9. Appendix

Appendix 1	Questionnaire 04/98
Appendix 2	Questionnaire 04/01
Appendix 3	Countries' Responses to Questionnaires
Appendix 4	Safety Relevant Failures in Photovoltaic Systems
Appendix 5	Experiences with 30 Stand-Alone PV Hybrid Systems

Appendix 4 Safety Relevant Failures in Photovoltaic Systems

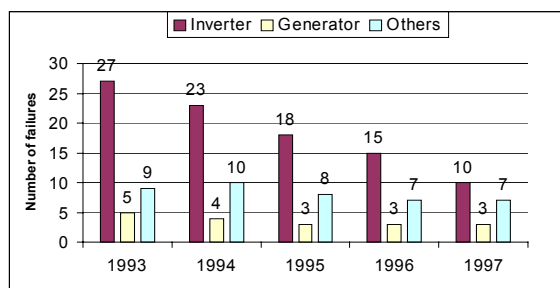
According to the reports of the plant owners, 65% of the total number of failures was caused by inverter defects. Frequency and number of system failures decreased significantly during the project realisation thus proving the relevance of the 1000-Roofs-Project for the development of system technology (Fig. 3).

Figure 3: Reported failures per component (per 100 systems, considering PV systems with any data available for the corresponding year).

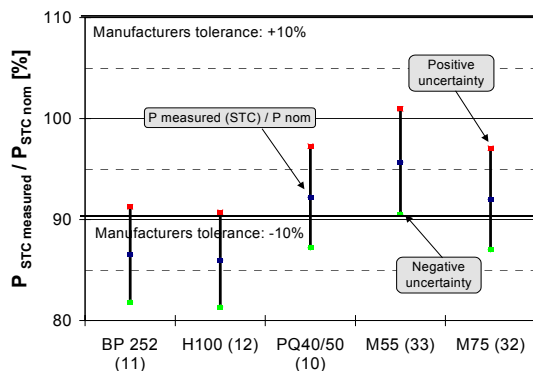
Figure 5: Mean deviation of operating power of various solar generators compared with the module nominal power for five typical module types.

The determination of the generator power at STC frequently revealed power deficits of 10 to 20% compared with the datasheet values given by the module manufacturers (Fig. 5). STC-power given in the data sheets could only be reached by two module manufacturers, for one type a general technological failure seems to become evident.

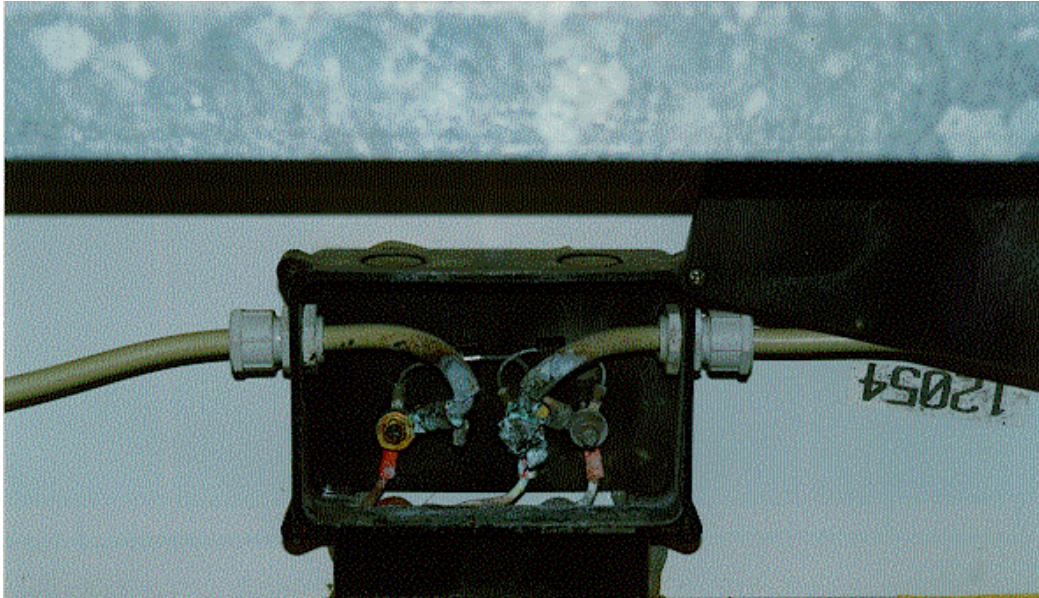
Thus, under insolation j-boxes contain air of a certain humidity. At night this air cools down and the vapour condenses leaving plain water drops in the junction box.

Figure 1: Damaged junction box; Apparently water penetrated and could not drain. It caused corrosion of contacts virtually disabling the module.

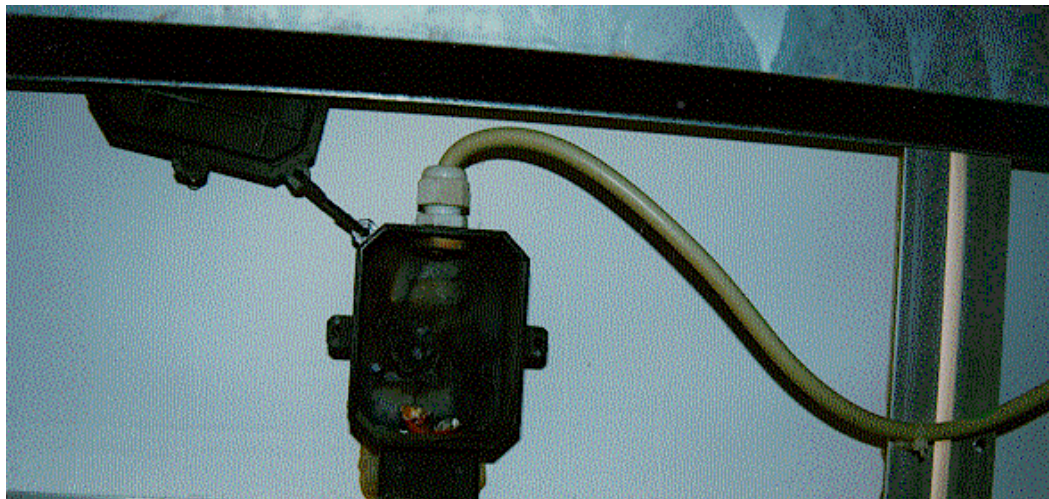
Figure 2: Wire from the top leads water into the j-box. The interior had been destroyed by an arc.
