9. Appendix

Appendix 1	Questionnaire 04/98
Appendix 2	Questionnaire 04/01
Appendix 3	Countries' Responses to Questionnaires
Appendix 4	Safety Relevant Failures in Photovoltaic Systems
Appendix 5	Experiences with 30 Stand-Alone PV Hybrid Systems

Appendix 4 Safety Relevant Failures in Photovoltaic Systems

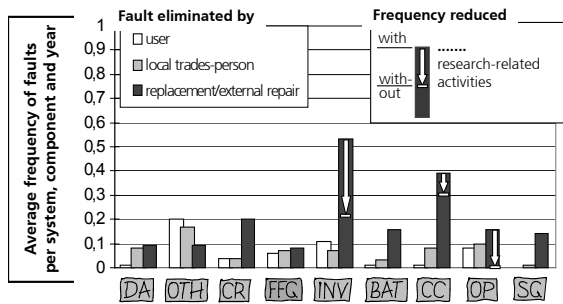
Fig. 2: Average frequency of faults (abbreviations, see fig. 1) per system component and year.

Exclusion of faults which are directly related to research leads to only a few but then very clear reductions, which are indicated in the graph with arrows in the appropriate bars.

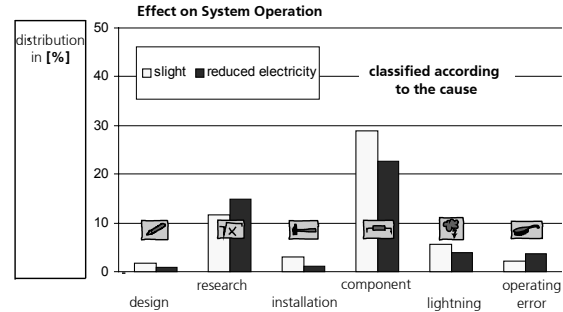
Fig. 3: Distribution of system operation restriction according to intensity and causes.

It is pleasing to note that hardly no fault led to a complete system breakdown. This is due to the deliberate duplication found in almost all systems, namely the photovoltaic system on the one hand and the fossil-fuelled generator on the other, so that an emergency power supply is guaranteed as far as possible.

System faults are most frequently caused by faults in individual devices. These are due to a wide variety of causes, e.g. the effect of lightning or operating errors. However, as can be seen in fig. 3, these "external causes" are seldom responsible for device faults. These are primarily due to aging-induced component defects, which are thus classified in the "component" category. The research-related activities follow with the second highest frequency.

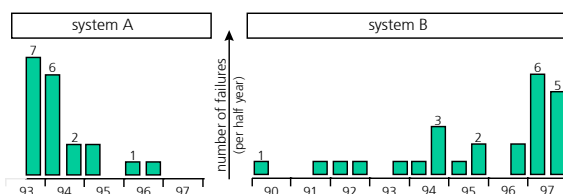
In general, one expects to find a higher frequency of faults shortly after taking a system into operation and again toward the end of the individual component lifetimes, if a system is observed over many years. This pattern can be confirmed only for a few systems (see fig. 4).

Fig. 4: Examples for a concentration in the fault frequency soon after commissioning (system A) and at the end of component lifetimes (system B) - number of faults per half year.

In many systems, there was not any noticeable reduction in faults after commissioning, i.e. there is still potential for technical development to reduce the fault frequency.
